THE STORY OF 'PLONK" A FORLORN MATCHLESS G 80

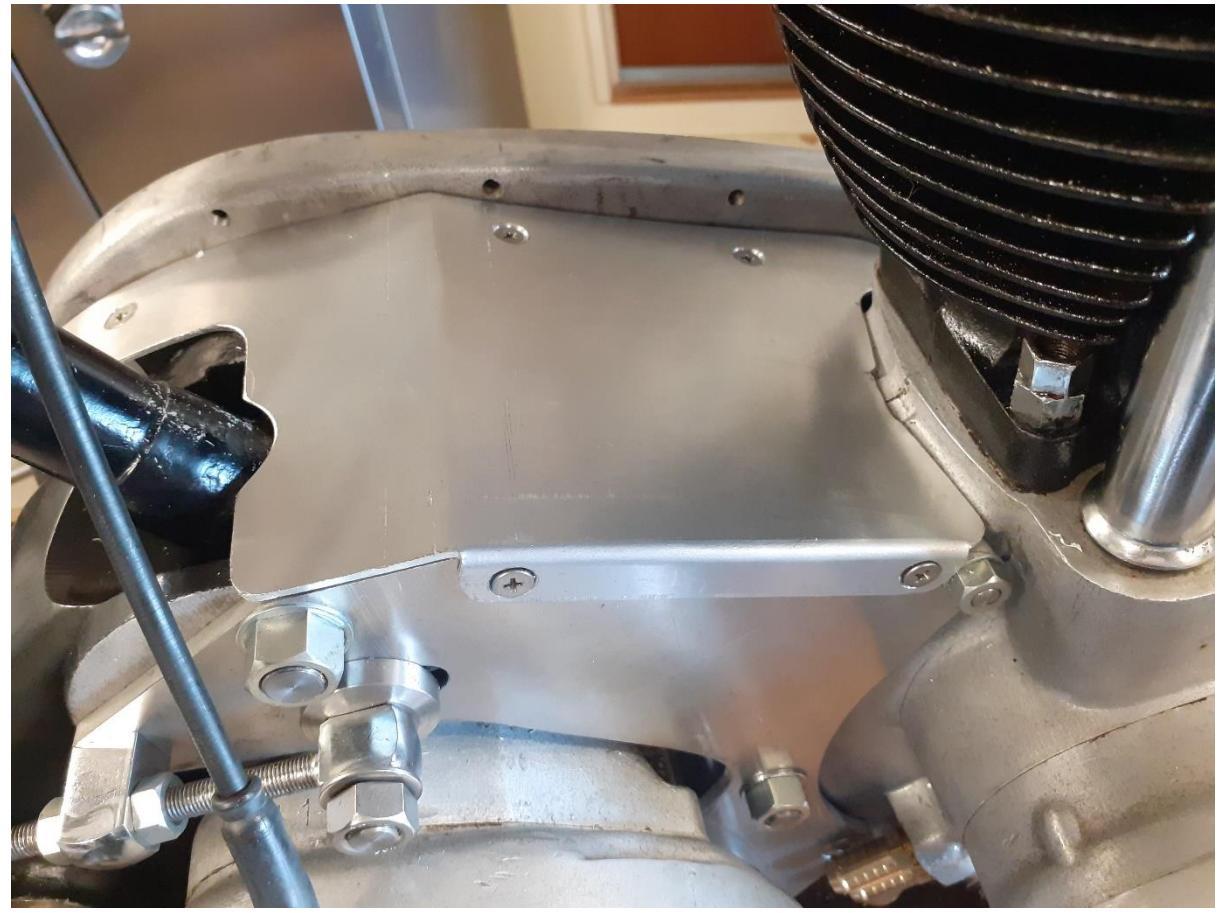
Making up a complete new set of control cables soon revealed that the primary chain case was now being fouled by the clutch, particularly when operated. A spacer behind the engine mounting point and a good 'tweak' of the inner case solved that issue. However, there is a hole the size of the 'Chunnel' where the gearbox input shaft enters the rear of the chain-case. How any oil is expected to stay within the confines of the case is beyond me, some serious metal work will be required to affect any sort of seal in that area. Not quite sure what it will look like, but it will give me something to mull over as I await sleep one night.

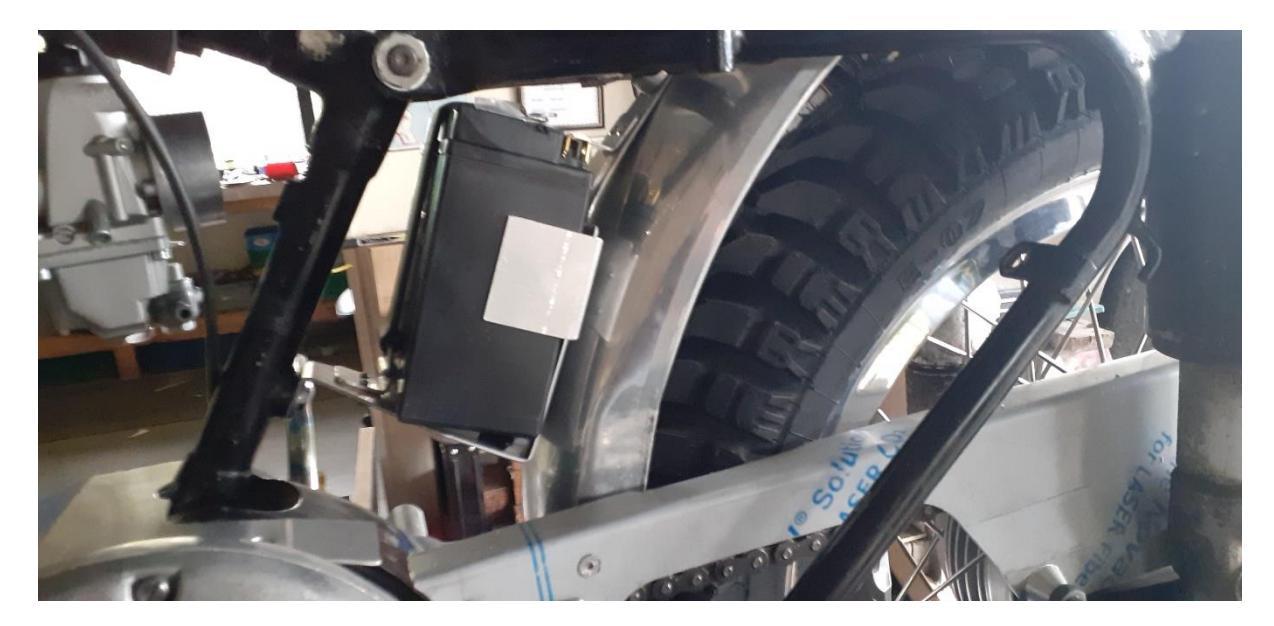
All the scraps of cardboard were thrown into the rubbish and the final shape of an oil tank, and a matching battery/air filter cover have resulted. Figuring out which of the myriad batteries would best suit was the next task and some head scratching and a call to our friendly battery man saw the item required delivered. Again, the cardboard was called into service and then a most intricately folded alloy platform was fitted with the battery sliding in very successfully.

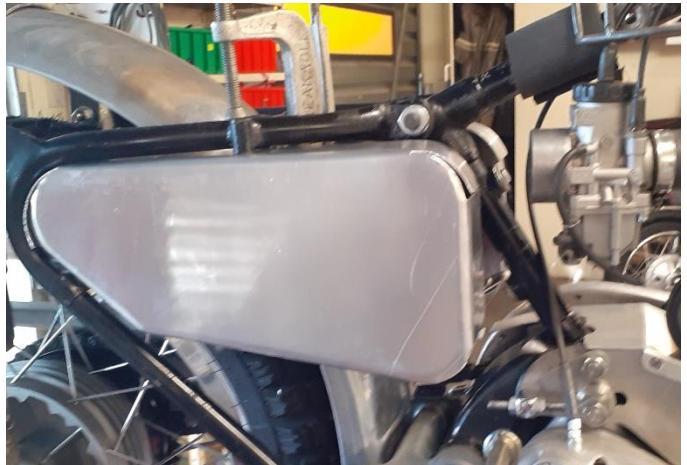
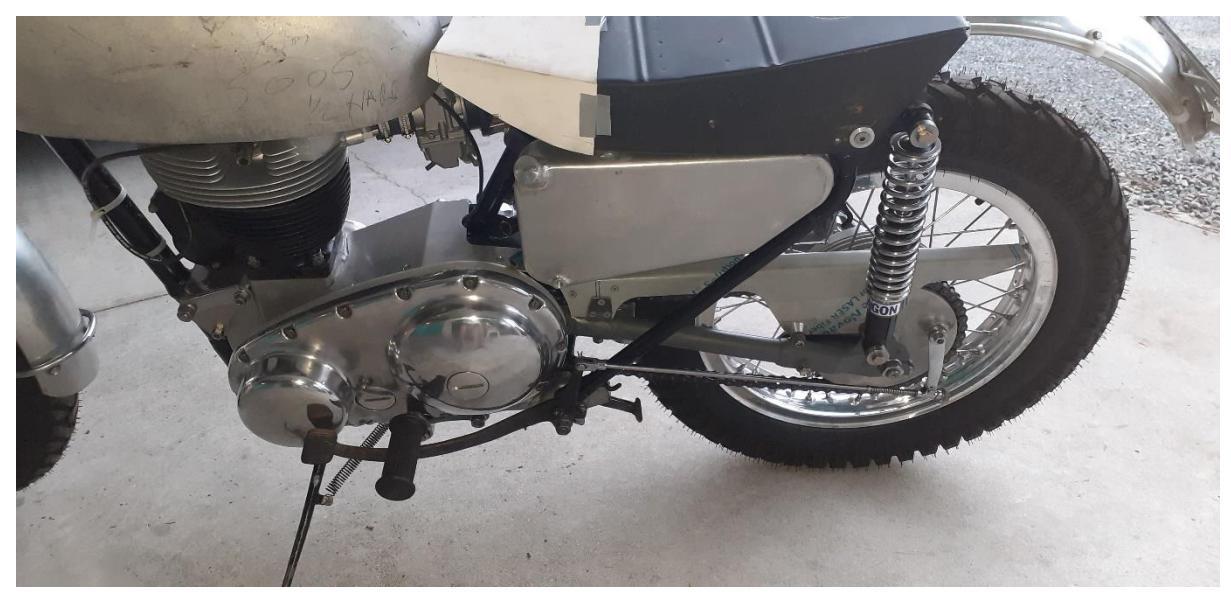
The easy side is the LH one, the battery cover, as it is open at the back, so once the corners have been 'glued' and dressed to the final required shape, it is complete. Its mounting is relatively straight forward, with a simple bracket requirement. The oil tank is a much more of a demanding mistress, however. Starting from the top it requires a filler with a screw top. A breather is also required to be fitted to the top surface somewhere and these are fiddly things as a baffle is really a necessity to allow air only to escape. The feed and return pipes are needed obviously, the feed requiring a filter of sorts to protect the oil pump from hedgehogs, small rodents and misplaced spanners that can find their way into the container, it needs to have a back welded in place and mounting points fitted. The biggest issue is the small space to fit the feed and return lines under the battery support and above the chain guard. The idea of fitting an oil filter in the return line was rejected as advice as to the power of the return pump was heeded.

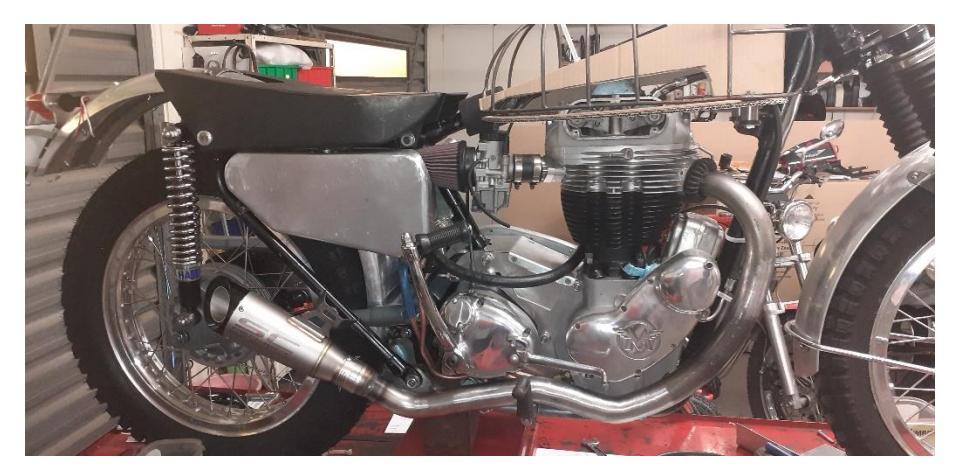
that I had purchased from a rather industrious Chinaman. This, together with a very expensive piece of bent tube from Armours in the UK, purchased unfinished, as I knew it would need to be well 'adjusted' before achieving its final form, would constitute the exhaust system. The first thing that was obvious was how loose the pipe was in the cylinder head, close inspection showed the head to be belled out at the exit. The lathe was pressed into service and a swage was turned up to press the required shape into a short piece of tube. This filled the bill well and then the serious cutting and welding commenced. I had purchased three 45-degree bends, and these were cut, reversed, tacked and finally the required pipe was constructed. In the myriad of parts that came with 'Plonk' was a set of the earlier footrests that were designed to be mounted on the inside of the lower frame rail, by mounting the RH one on the outside room was available for the pipe to pass inside. The footrest will need to be shortened by about an inch to bring it back to the original position, more welding required! The result is rather pleasing, a small mounting bracket was bent up to secure the muffler and the job is done. The price of chrome plating has pushed me in the direction of clever paint, which will do fine and there is always the option to chrome once I win a major Lotto prize!

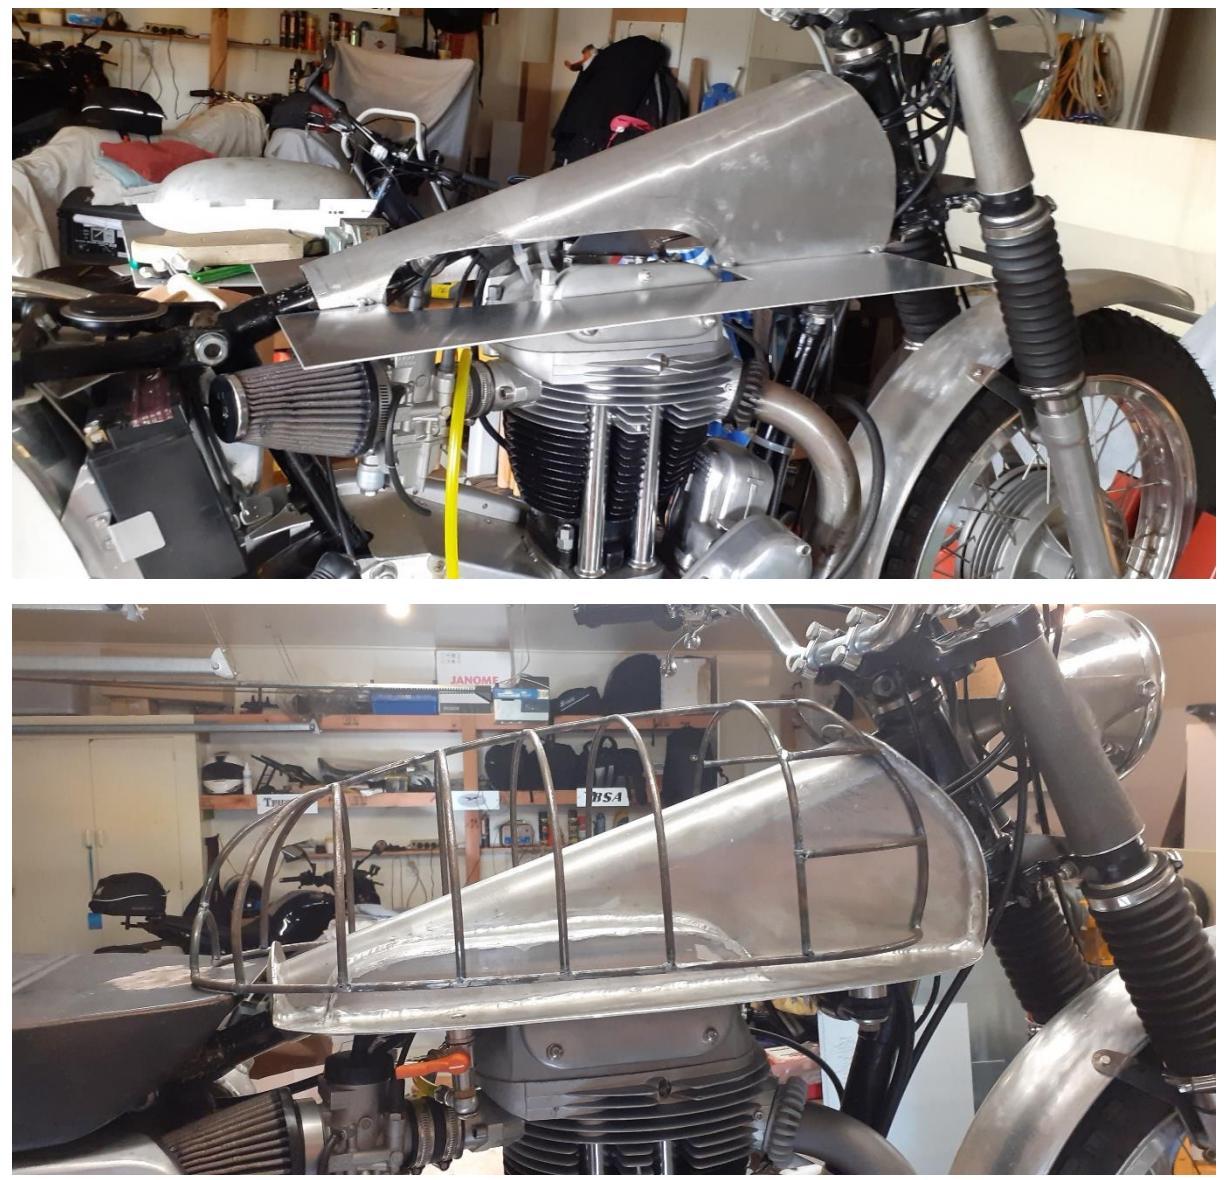
As can be seen in the following pictures, all the above has been done, now for the hard part.

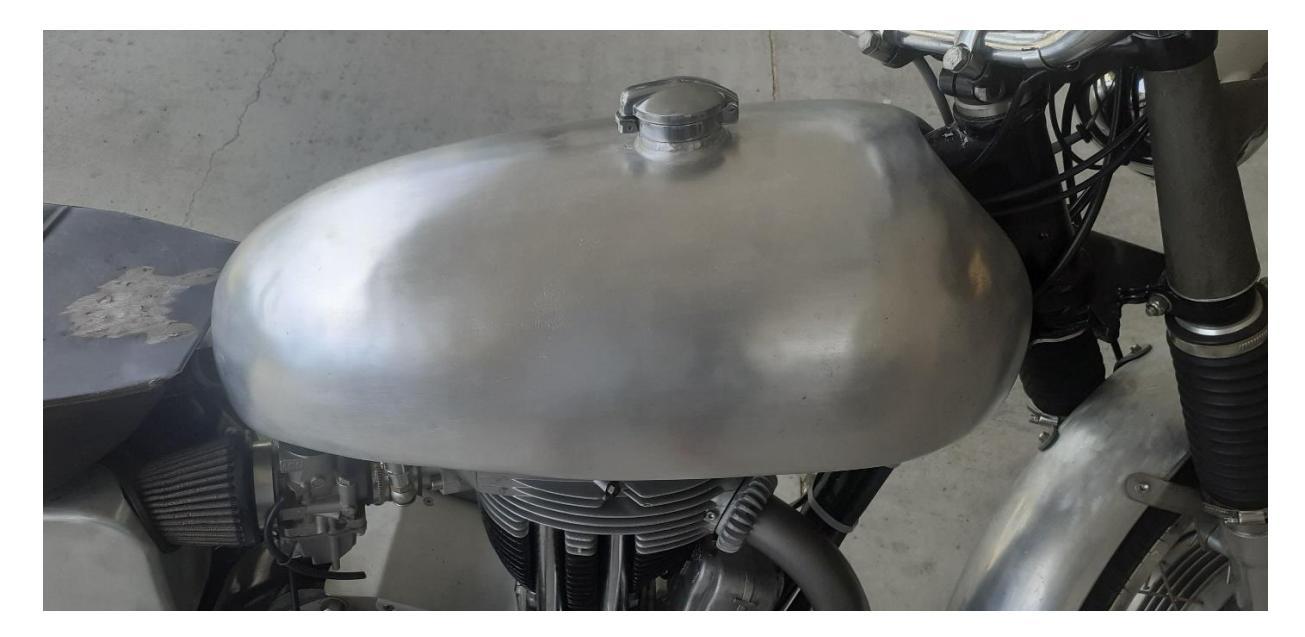
The grand plan was for the tank to be painted, but it doesn't look too bad, so may save some dollars and just ride it!! The end is now in sight as far as the major construction is concerned, the seat being upholstered is the final piece of the AMC jigsaw to be fitted together. Once that is done and all is back from powder coaters and the paint is dry it is time to see if it actually goes! I had proved to myself that I was indeed a silly old fool by attempting to time the magneto with the oil anti drain-down valve turned off, thus shorting out the low-tension circuit of the magneto! Once this had been realised and the sequence repeated all went as it should.
